**DANCE HALL FIRE
GOTHENBURG, SWEDEN
OCTOBER 28, 1998**

**FIRE
INVESTIGATIONS**

Dance Hall Fire

Gothenburg, Sweden
October 28, 1998

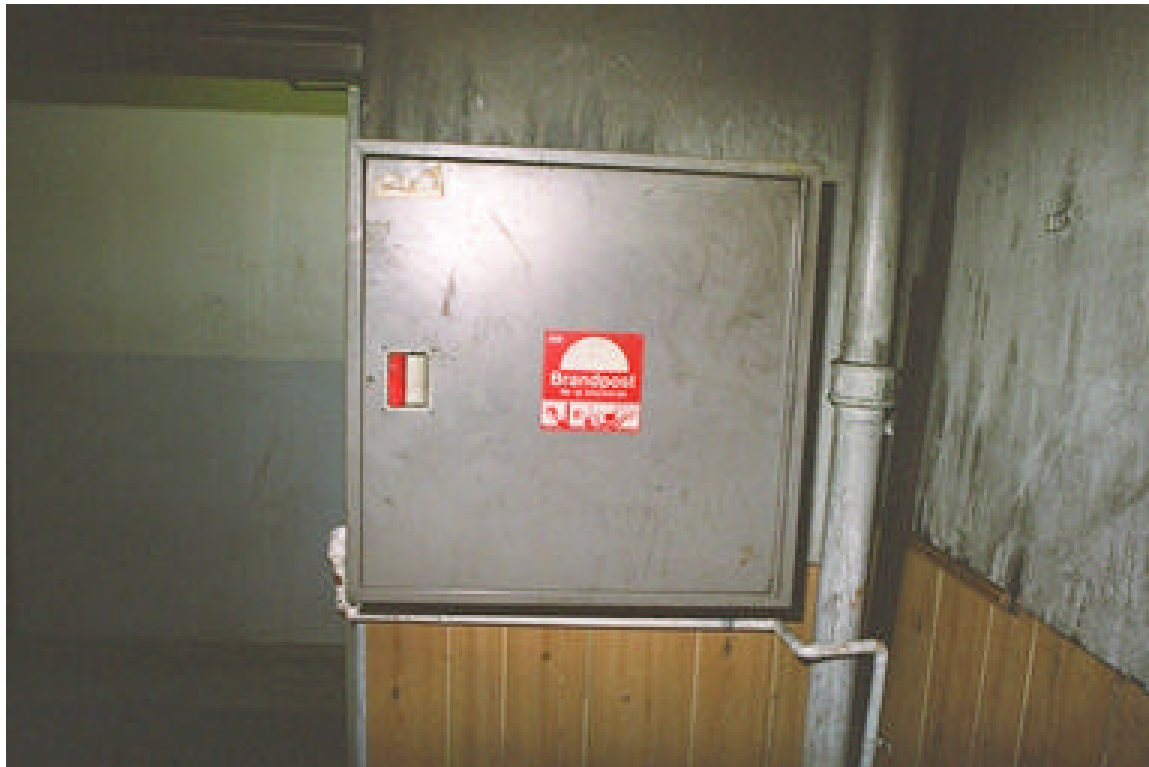
The building was not equipped with an automatic fire alarm or fire sprinkler system. There was an occupant-use hose cabinet in the northwest (main) entrance on the second floor of the building. (It is unknown if this was a wet or dry system.) (See Photo 1)

Photo No. 1 – An occupant-use hose cabinet was located in the entrance corridor adjacent to the exit stairway. (NFPA)

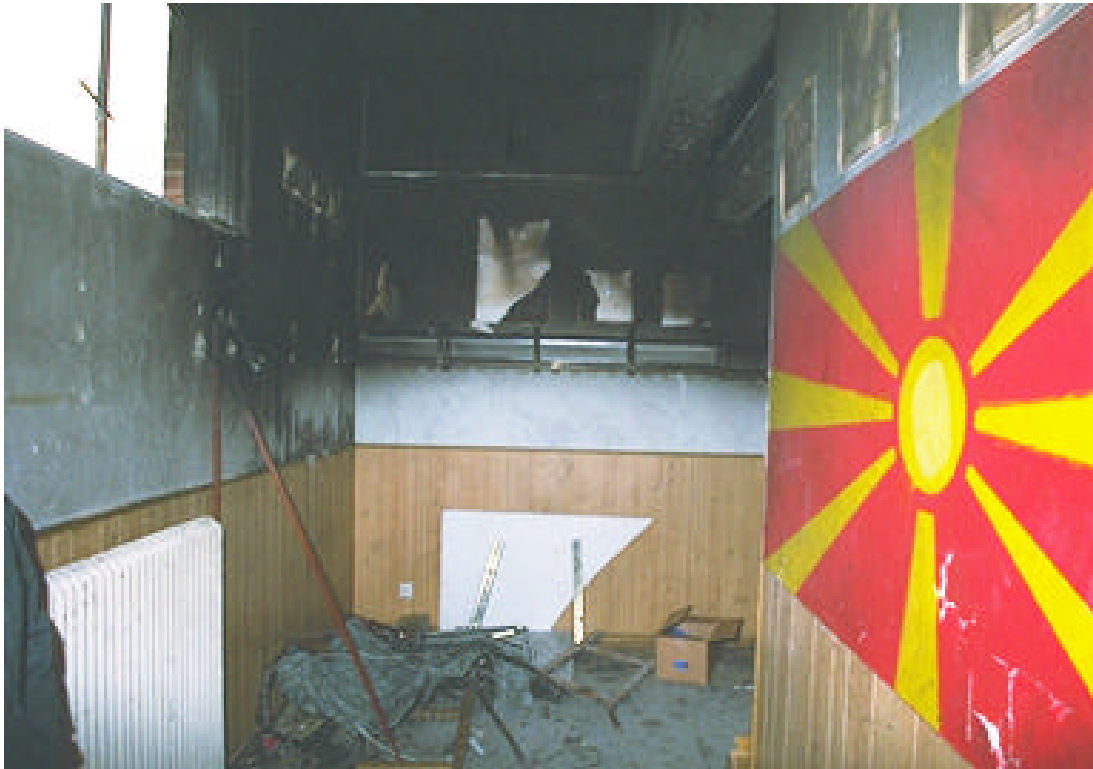
Photo No. 2 – View from the main entrance, leading into the hall. To enter the hall, the occupants would turn right, just beyond the flag on the wall. (NFPA)

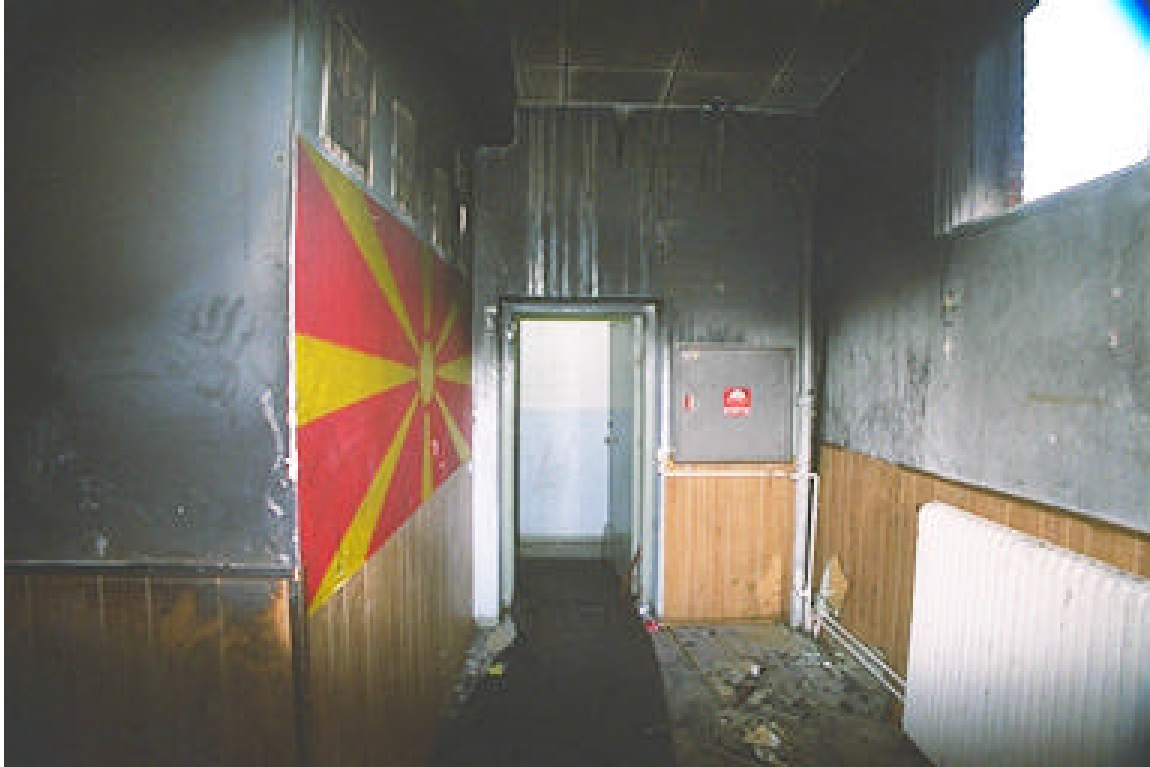
Photo No. 3 - The view towards the main entrance/exit. The dance hall is to the photographer's left in this view. (NFPA)

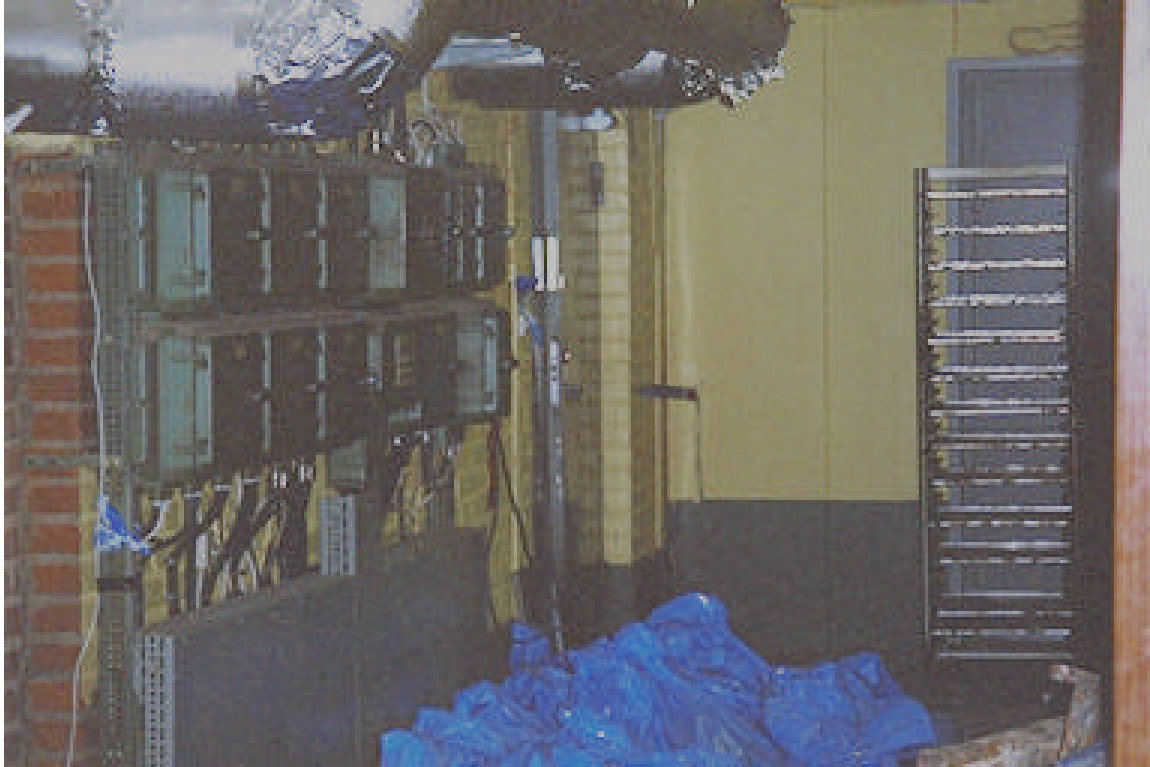
The other means of egress was located in the southeast end of the hall. This entrance was also equipped with a 0.8 m (31.5 in.) wide door that swung in the direction of egress travel. This door was constructed of combustible material, but had a 30-minute fire protection rating and was equipped with an automatic door closer. This door led to a 1.5 m (59 in.) wide stairway that led downstairs to the first floor. The remains of furniture were found in this stairway. One of the survivors reported to investigators that some of the furniture in the hall had been placed in the stairway to make more room. (See Photo 4)

Photo No. 4 – The door at the bottom of the southeast exit from the hall discharged into a common corridor area. (NFPA)

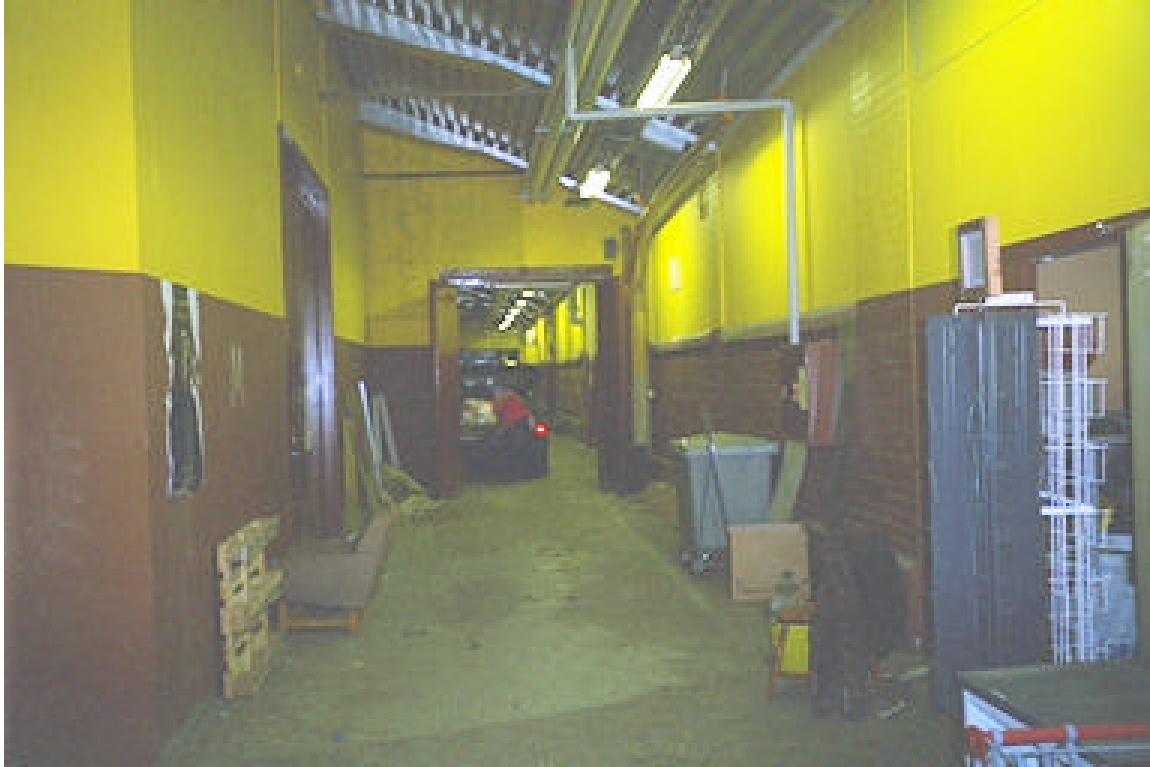
Once they were on the first floor, occupants would have then been required to traverse a path that measured approximately 100 m (328 ft) before reaching a door that discharged to the exterior. According to personnel from the fire brigade, this corridor had a one-hour fire rating. This corridor eventually widened sufficiently so that vehicles could enter it to make deliveries and pickups. (See Photo 5 and Figure 5)

Photo No. 5 – Occupants would have to traverse this corridor to ultimately reach an exit. (NFPA)

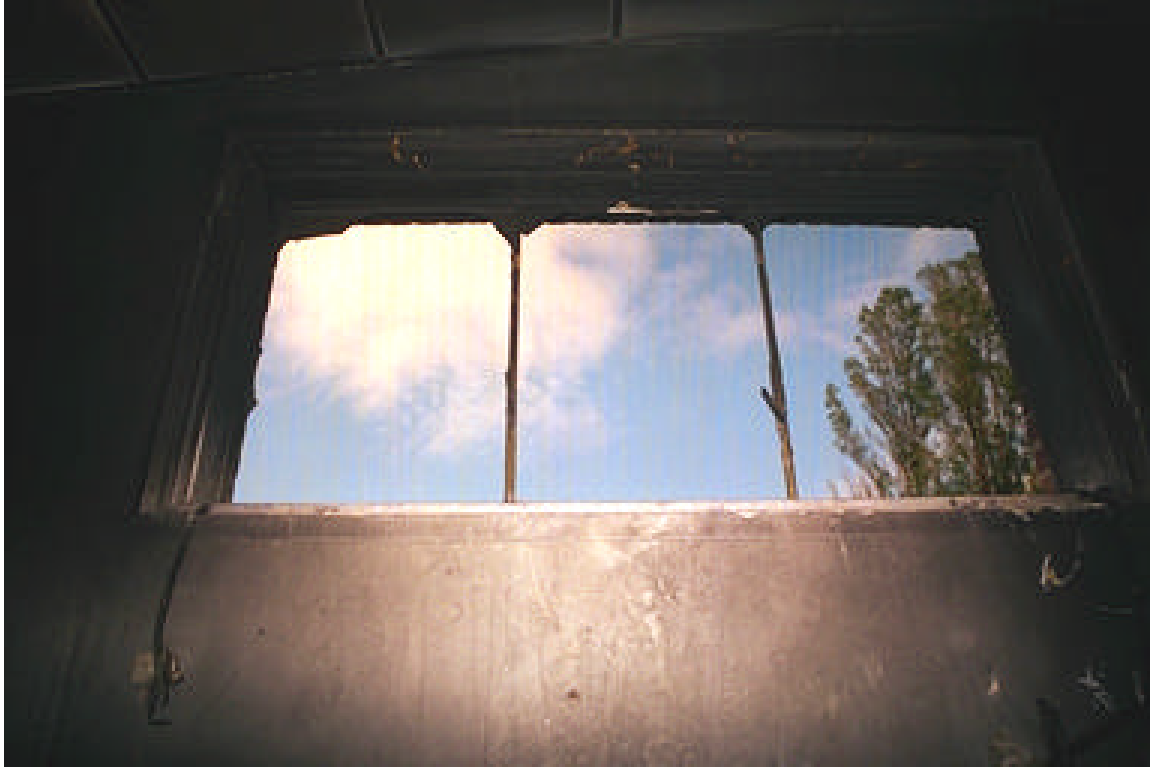
Because of the congestion being caused by the number of people attempting to flee the fire through this one door, others broke out the windows on the northeast wall and jumped to the ground from a height of 6 m (20 ft). These windows were 2.2 m (7.2 ft) above the floor, so it must have been difficult for the occupants to use these windows as a means of escape from the building. (See Photo 6 and Photo 7)

Photo No. 6 – Interior view of window that occupants broke out and jumped from on second level of building. (NFPA)

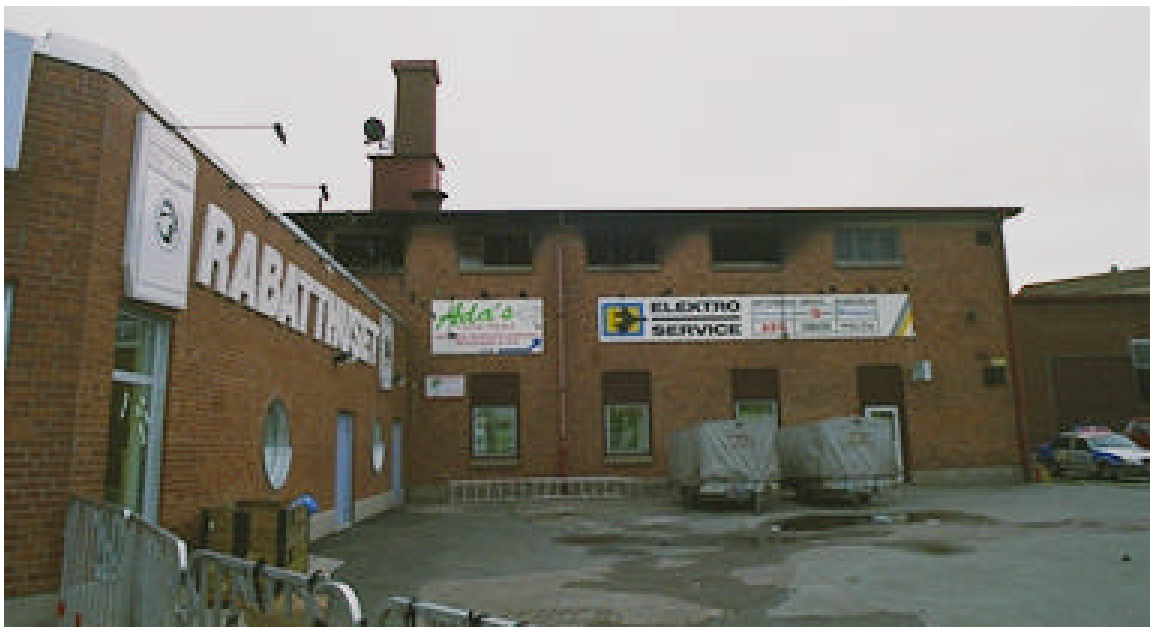
Photo No. 7 – Exterior view of building showing the windows that had been broken out on the second floor and where occupants jumped to the ground. (NFPA)

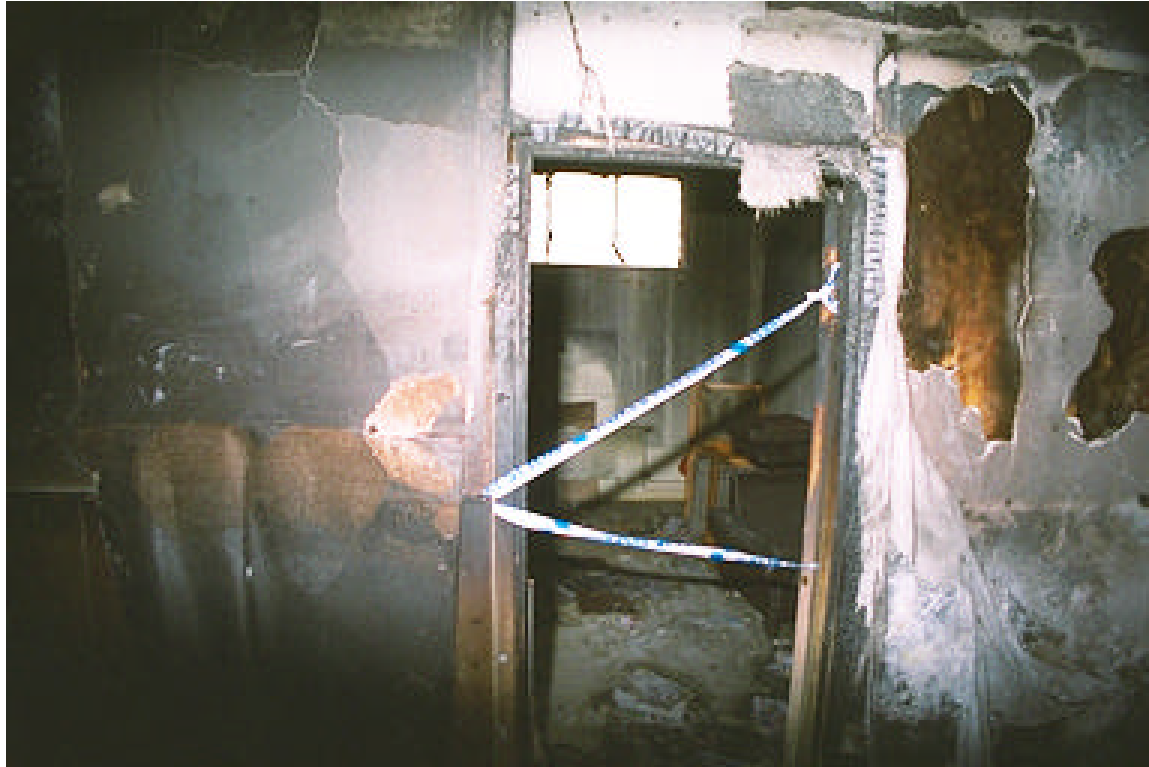
Once the fire was suppressed, 20 additional victims were found in a small room at the northwest end of the hall (room #203). It is theorized that these people were attempting to flee the fire through the main exit when their way was blocked by the

large number of people attempting to pass through the one door. They then attempted to take refuge in the room, but were overcome by smoke. The command officer reported that there were victims piled three to four feet deep in this room. (See Photo 9)

Photo No. 9 – In Room 203 a number of victims had attempted to take refuge from the smoke and flames. (NFPA)

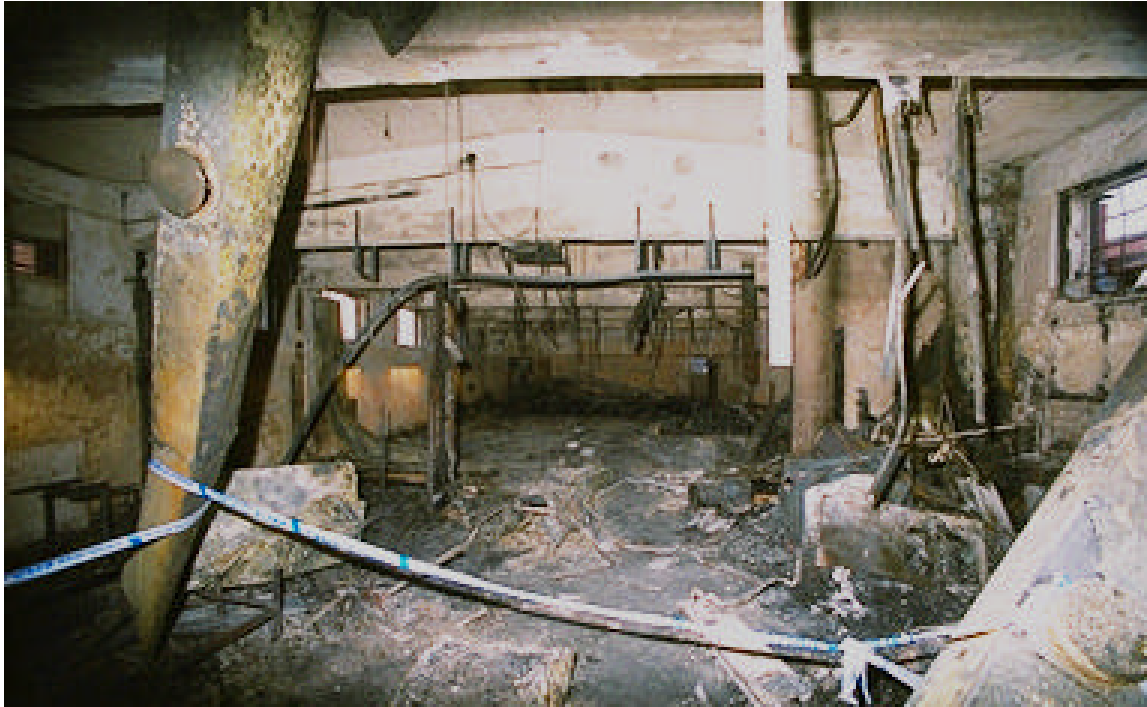
The main hall area was severely damaged by the fire. The ceiling assembly was also destroyed. Seven of the eight exterior windows on the northeast side were totally destroyed. All five windows on the southwest side were also destroyed. (See Photo 10)

Photo No. 10 – This is a view of the interior of the main hall from the entrance looking towards the stage. (Note: None of the contents had been removed from the area when this photo was taken.)

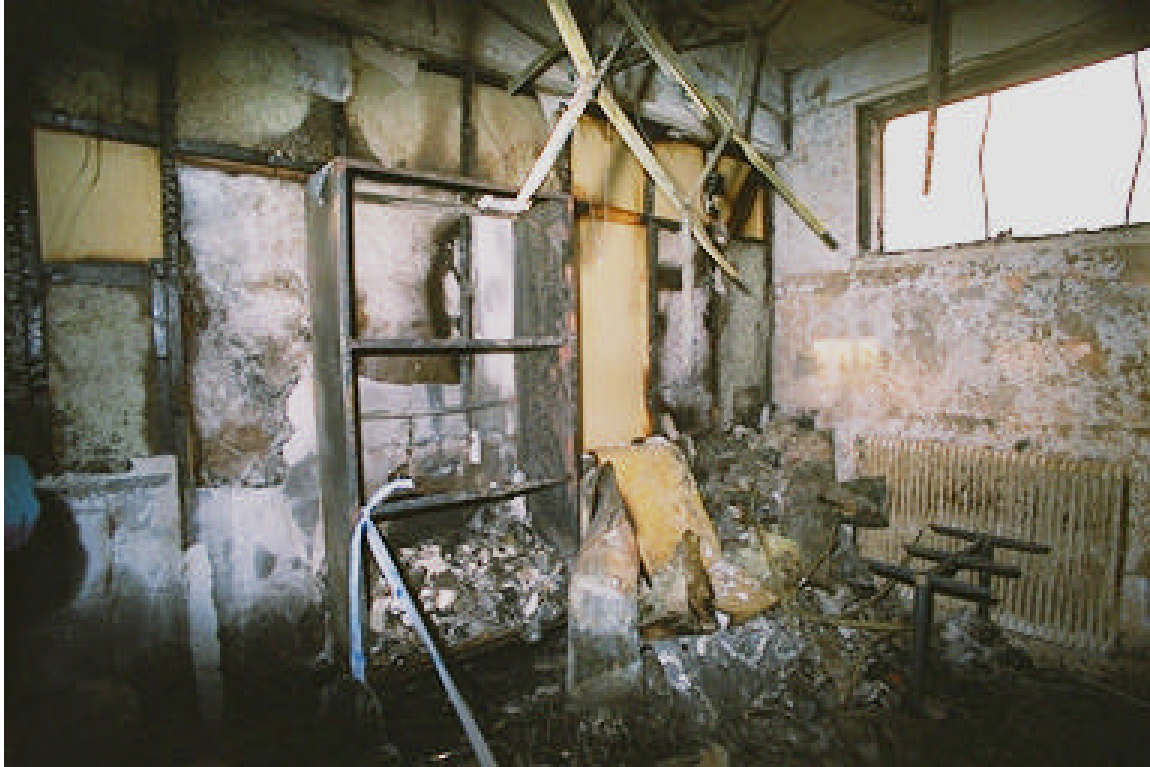
Room #203 on the northwest end of the hall had heavy smoke damage. This is the room where a large number of people attempted to flee the fire and were overcome by smoke. The condition of the door to this room was unknown. However, the glass panels at the top of the wall to this room were totally destroyed by fire. The next room moving further towards the northwest room, room #202, received smoke damage from the fire. Reportedly this door was closed and locked during the incident, so no one was able to gain access to this room. (See Photo 11)

Photo No. 11 – This is the wall that separated Room #203 from the main hall. At the top of the wall were glass panels that failed during the fire, allowing smoke to spread into this room.

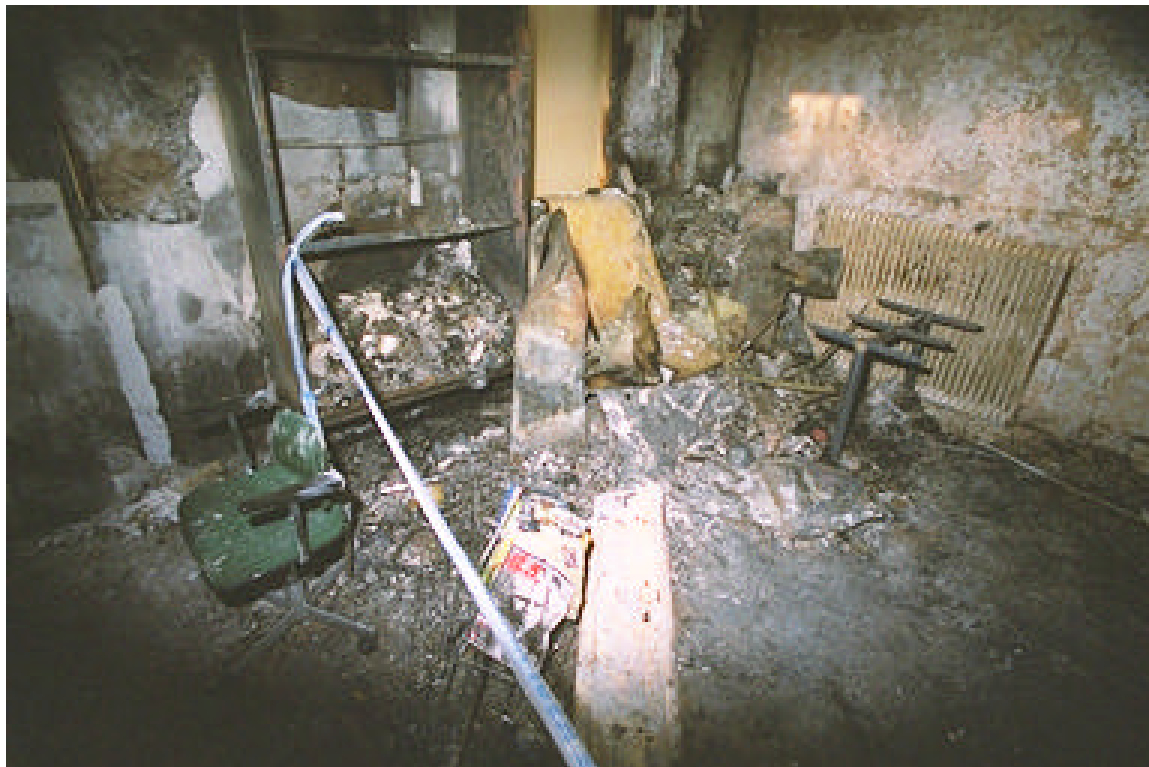
The fire was fueled by the presence of combustible furniture stored in the stairway. Once the fire spread into the hall from the stairway, it ignited the combustible furnishings and decorations. It then spread to the northwest throughout the hall. There were reports of combustible decorations hanging from the ceiling and on the walls that would have also fueled the fire. The type and quantity of these decorations is unknown. The interior finish in the hall was possibly comprised of combustible wood paneling, which provided an additional fuel load. (See Photo 12)

Photo No. 12 – The furnishings in the Main hall comprised mainly of combustible materials over metal frames.
